Merion Friends Meeting House: Documentation & Site Analysis

David Mark Facenda
University of Pennsylvania

MERION FRIENDS MEETING HOUSE: DOCUMENTATION & SITE ANALYSIS

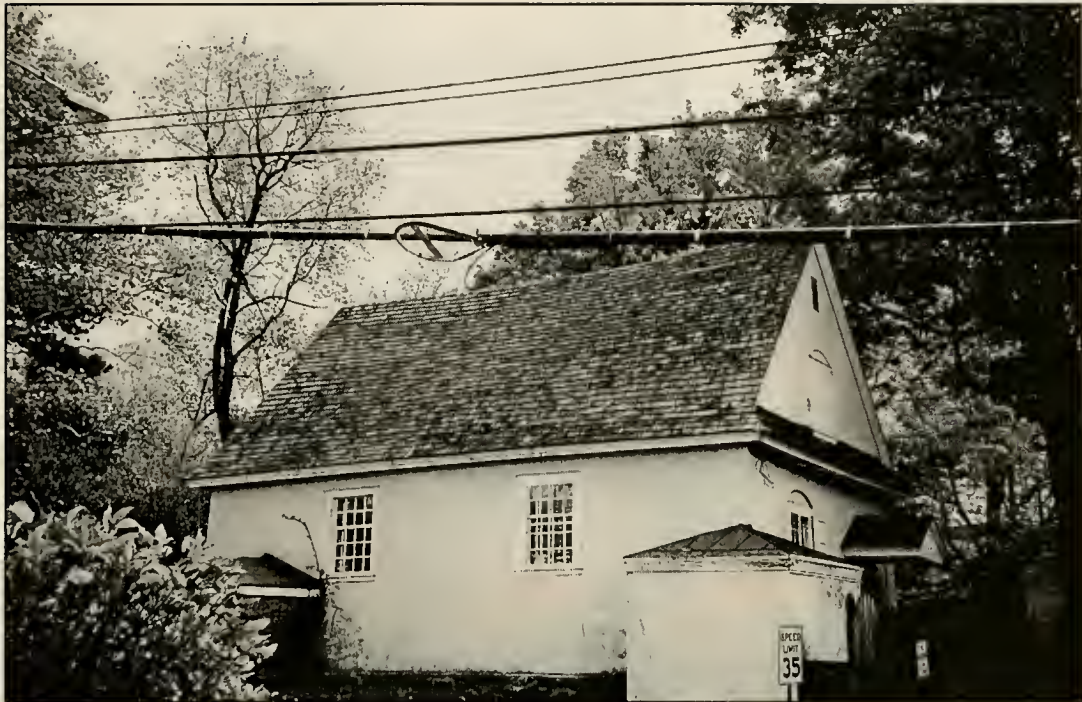
There are two, symmetrically spaced, eight-over-twelve-light, double-hung sash windows located on the north elevation of the building (Figure 8).

Figure 8: North exterior elevation with flanking privy additions.
 Photograph by author, 2001.

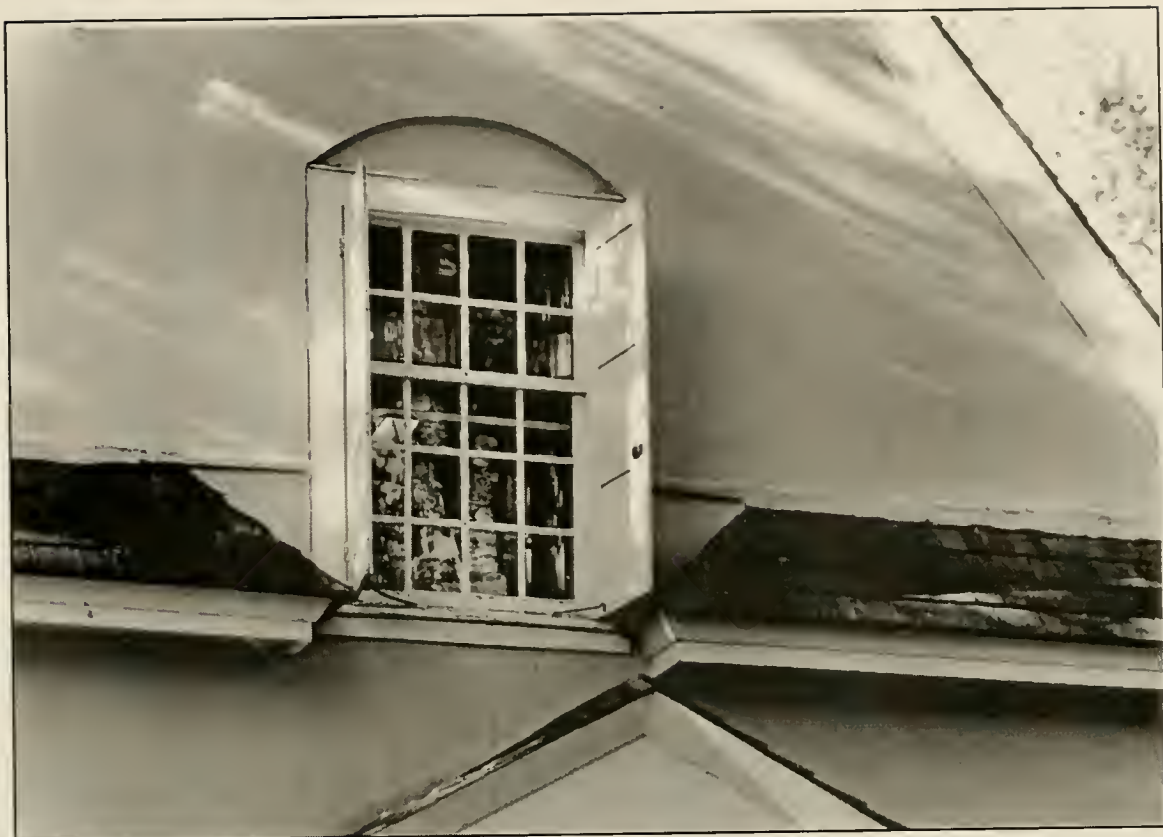
Figure 12:
Loft window and broken pent roof, south exterior elevation.
Detail from HABS photograph No. PA-145-17 by Jack E. Boucher, Photographer, 1997-1999.

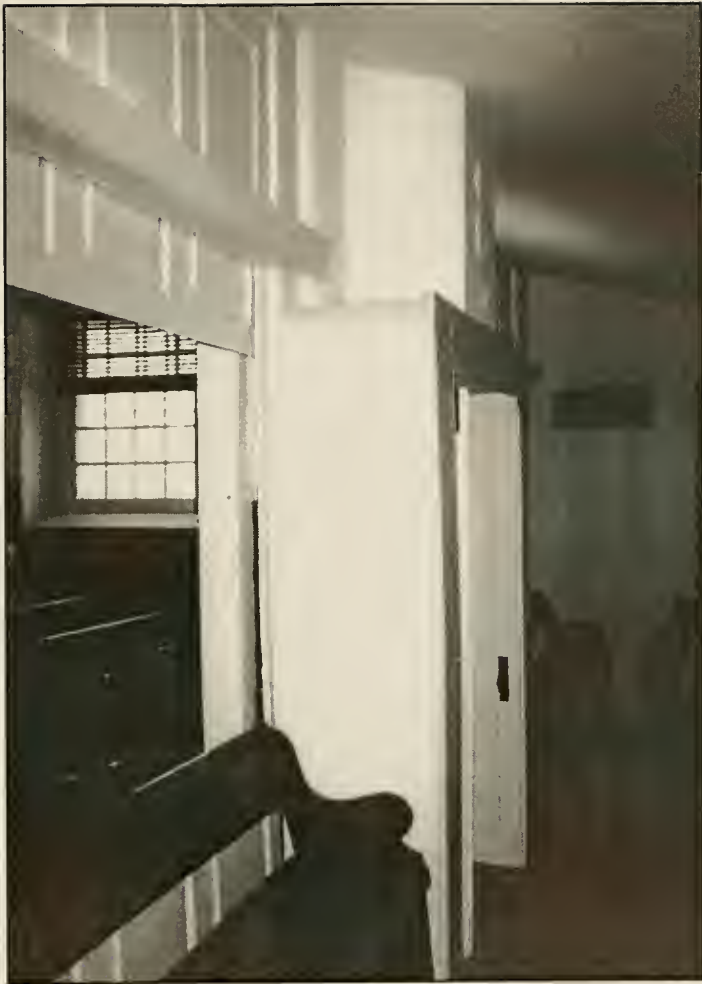
brick chimney above (Figure 18). It was most likely built circa 1829 when the central chimney was added to the meetinghouse to receive the stovepipes of wood- and coal-burning stoves installed on the ground floor.

Figure 18:
Masonry chimney support and
passageway. The base of the chimney can
be seen above the doorway.
Photograph by author, 2002.

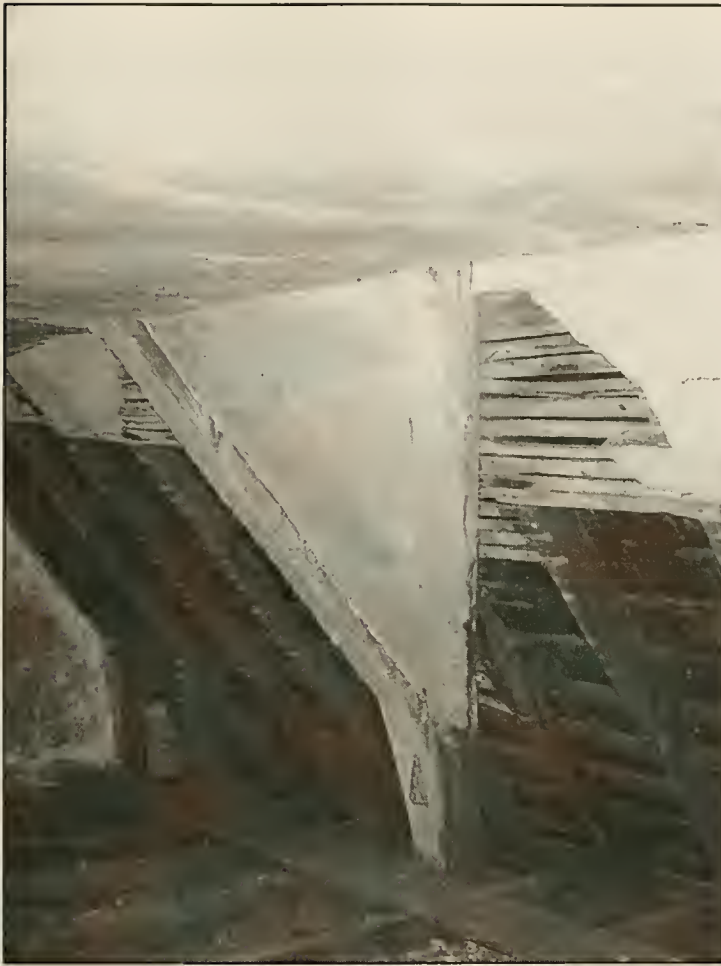
Various sources have speculated that the ceiling over the south room may have been lowered at some unknown date to provide more space for the loft above. Some have interpreted the height of the plaster to indicate that the ceiling was once at the height of the eaves or at the level of the tops of the masonry walls. A rough plaster finish still covers the east and west stone walls to the height of the rafter plates in the south section (Figures 24 & 25). (A later application of plaster raised the height another thirty inches). The floor joists that support the loft floor and suspend the ceiling over the south room are positioned 2-½ feet below the height of the rafter plates. The disparity between the height of the plaster and the level of the ceiling has been interpreted to indicate that the position of the loft floor was altered.

Attic space above dropped ceiling. Plaster shows original ceiling height at collar beams. The "cruck" principal rafters were partially exposed and whitewashed originally. Photograph by author, 2002.

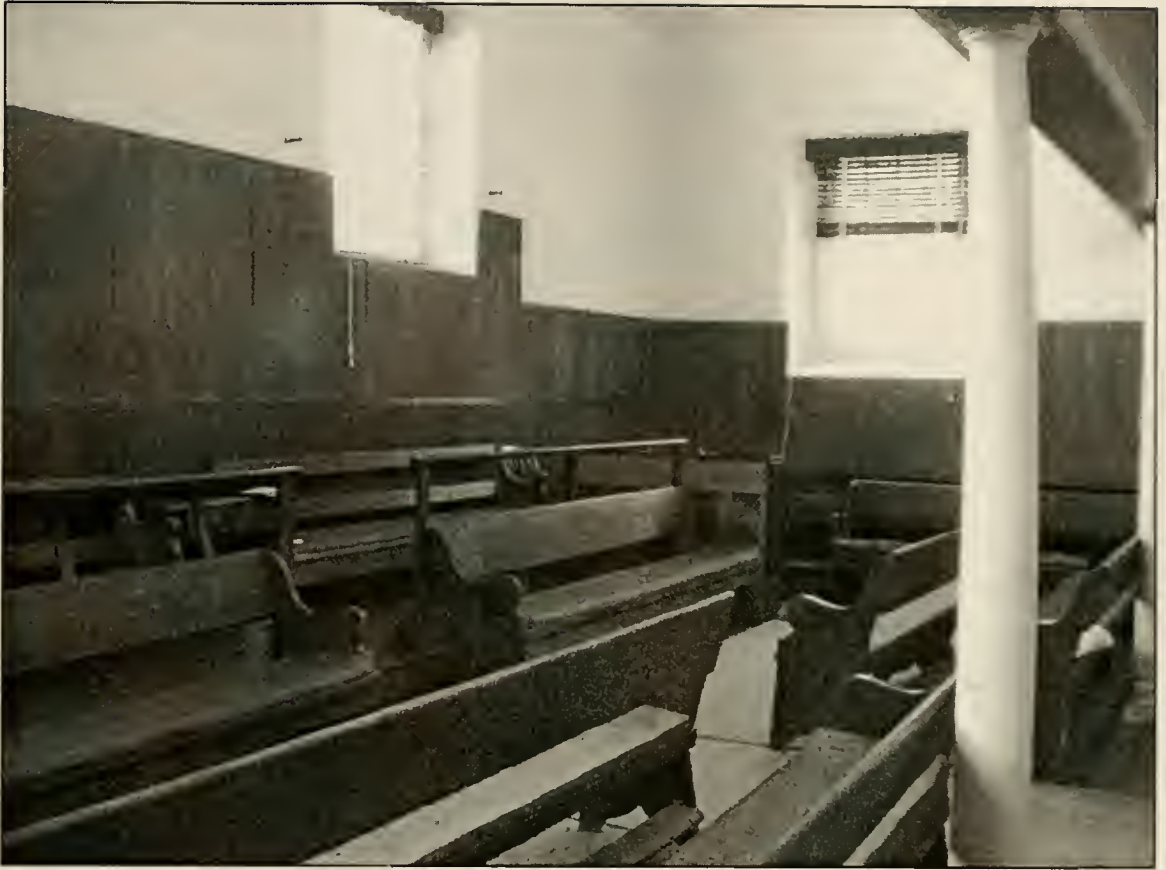
A ministers' or elders' gallery, also known as the "facing benches," is located along the north wall of the principal meeting room facing south (Figure 21). The ministers' gallery is a tiered wooden structure providing a series of elevated platforms and fixed benches, where the elders and clerk of the meeting traditionally sit while meetings are conducted. The wainscoting directly behind the ministers' gallery rises to 8 feet 8 inches in height. The ministers' gallery is single-tiered. Evidence of nail holes in the wainscoting behind the gallery and the curious height of the hat pegs on the wall over the benches suggest that the gallery was lowered from three tiers to one at some point in time. These changes likely occurred circa 1829 as part of the campaign to "Repair" and update the meetinghouse. There is a single-tiered platform with a bench facing perpendicularly to the ministers' gallery located against both the east and west walls of the north room. These ancillary platforms are twentieth-century additions, probably built when the new flooring was installed. Several more rows of moveable wooden benches rest directly on the floor and face north. A center aisle leading to the ministers' gallery divides the room in half.

Figure 21:
Ministers' gallery, also known as the "facing benches," in north room. Note position of hat pegs above the wainscoting on the north wall. Evidence suggests that the ministers' gallery was lowered from three tiers to one. Photograph by author, 2002.

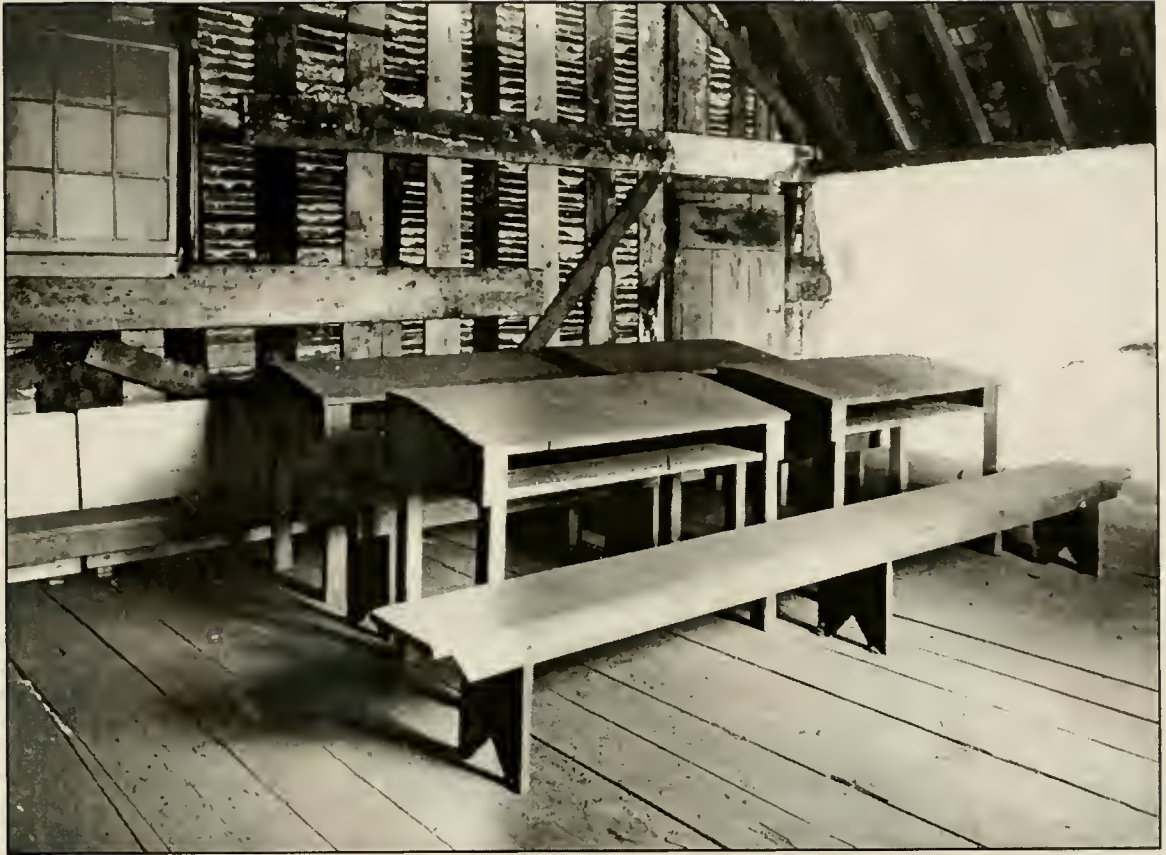
Figure 24:

At the back of the balcony, there is a plastered partition wall with a door that leads to a loft area over the south room. This loft area is believed to have been a schoolroom at one time. The south side of the partition wall separating the balcony from the loft is unfinished (Figures 24 & 25). Framing members and lathing are plainly visible from the backside.

The partition wall that separates the present balcony from the loft space was constructed almost entirely of recycled parts (Figures 24 & 25). Random width boards positioned vertically and nailed to the collar beam of the principal rafter assembly above provide the basic structure of the current partition. Several additional boards positioned horizontally and diagonally reinforce and help stiffen the wall. Sawn-oak lathing attached to the north side of the vertical boards provides a surface for the plaster finish to adhere. The south face of the partition remains unfinished. Many of the vertical boards are stained with what looks like plaster or mortar. Some of the boards have patches where they have been white washed. The stains are relatively

Loft partition wall, south elevation, looking northeast. Photograph was taken before modern heating system was installed. Note the construction of the partition wall using salvaged materials. Photographer and date unknown. Merion Friends Meeting Archives Collection.

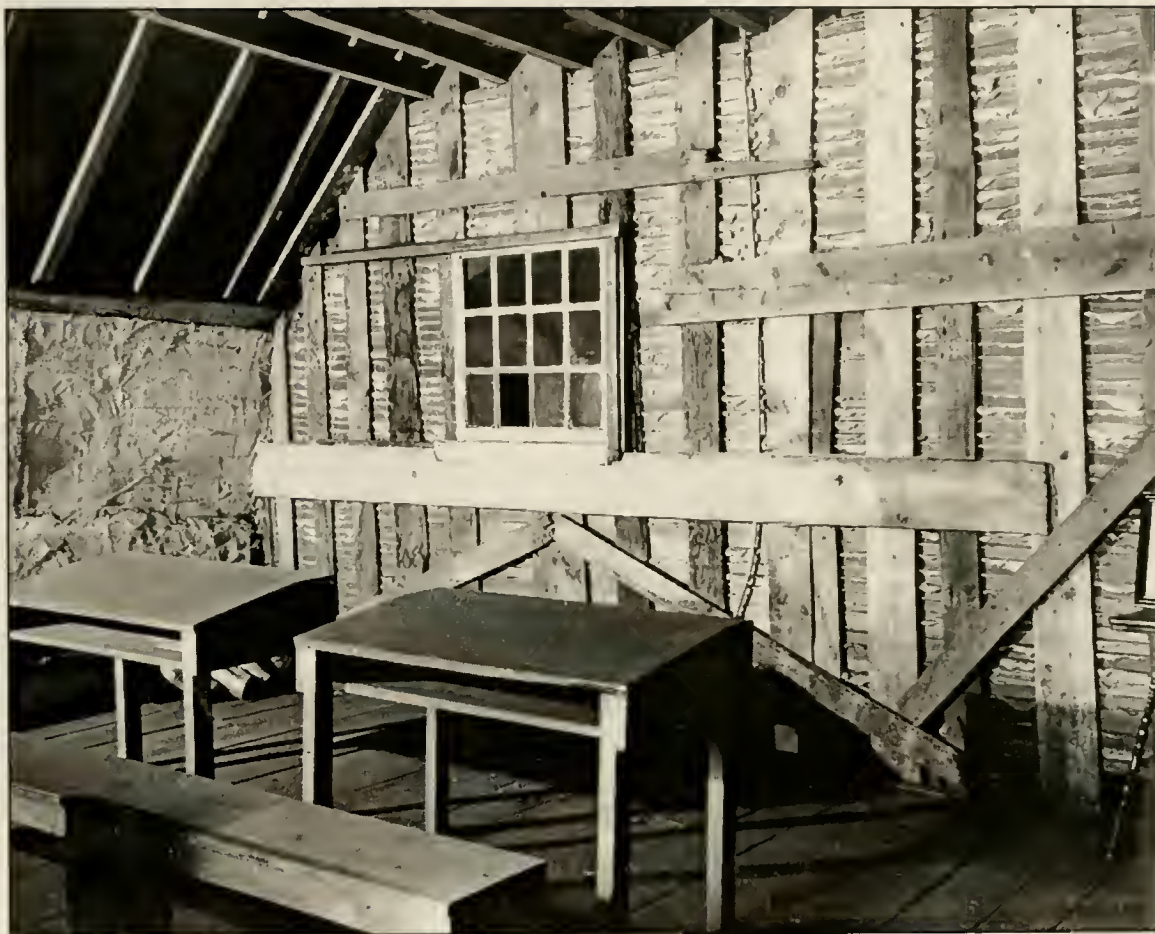
Figure 25:

Loft partition wall, south elevation, looking northwest. Photograph was taken before modern heating system was installed. The partition was built using recycled materials including the window sash. Note the plaster covering the masonry wall to the west. *Life* magazine photo for the Quaker section of "American Faith" series, 1945. Merion Friends Meeting Archives Collection.

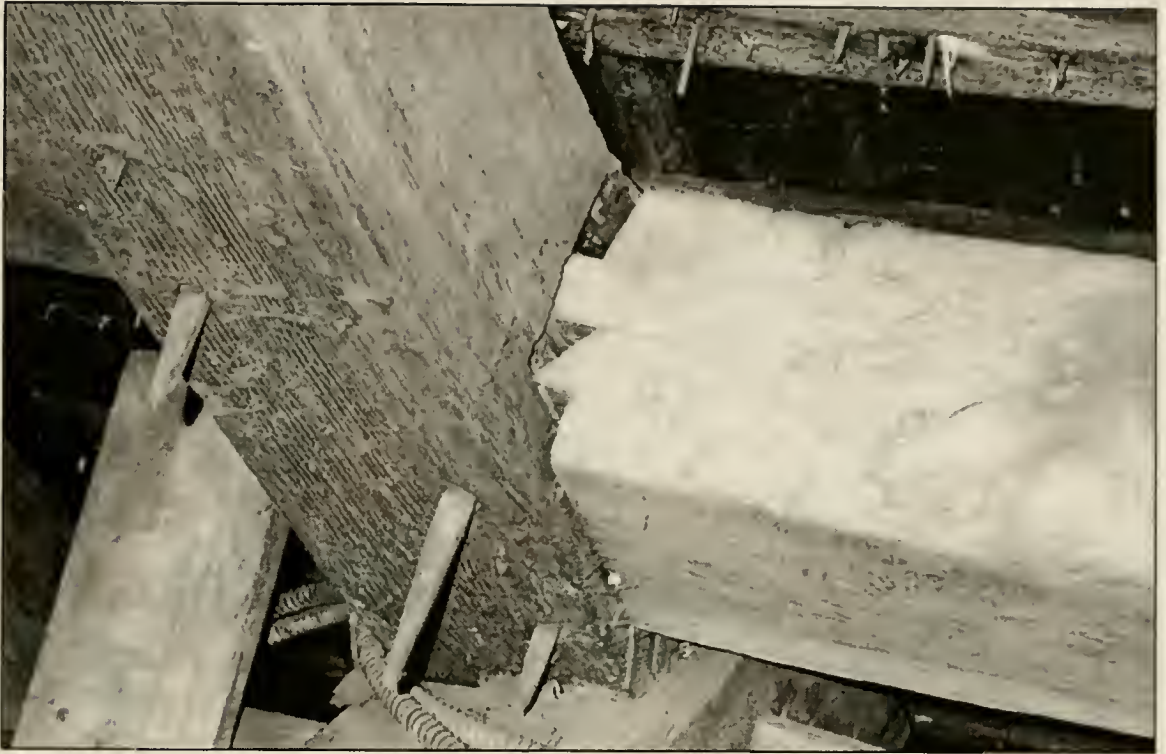
Instead of a ridgepole, the principal rafters are pinned together at the ridge with pegs. The rafters are joined and reinforced horizontally with offset purlins that span the distances between each bay (Figure 28). The heavy-timber purlins support a series of intermediate common rafters. The common rafters that extend above the purlins are pinned at the ridge and are connected to the purlins with mortise-and-tenon joints (Figure 29). The common rafters

Figure 29:
Detail of typical principal rafter and
purlin mortise-and-tenon joint.
Photograph by author, 2002.

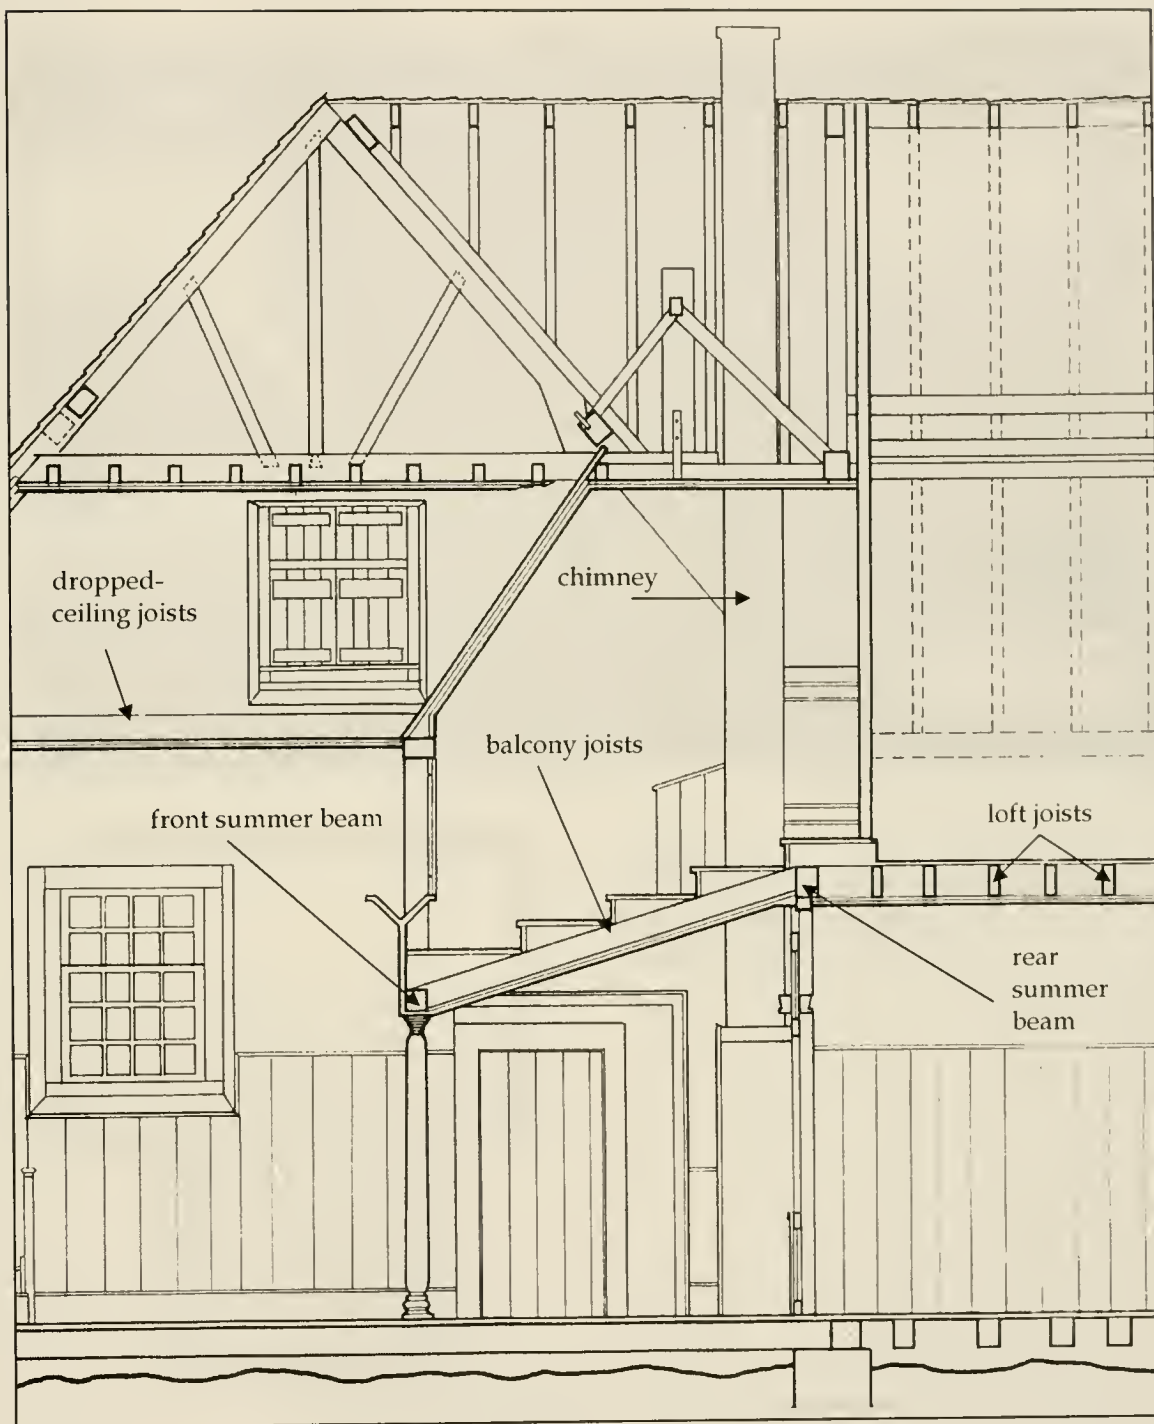
Figure 36: Plan of loft and current balcony framing installed c. 1829. Note mortise pockets spaced on 17-inch centers on south face of rear summer beam of the balcony. There are no mortise pockets in east six feet of the rear summer beam. The loft joists are pocketed into the masonry of the east and west walls. They appear to be original and unaltered.

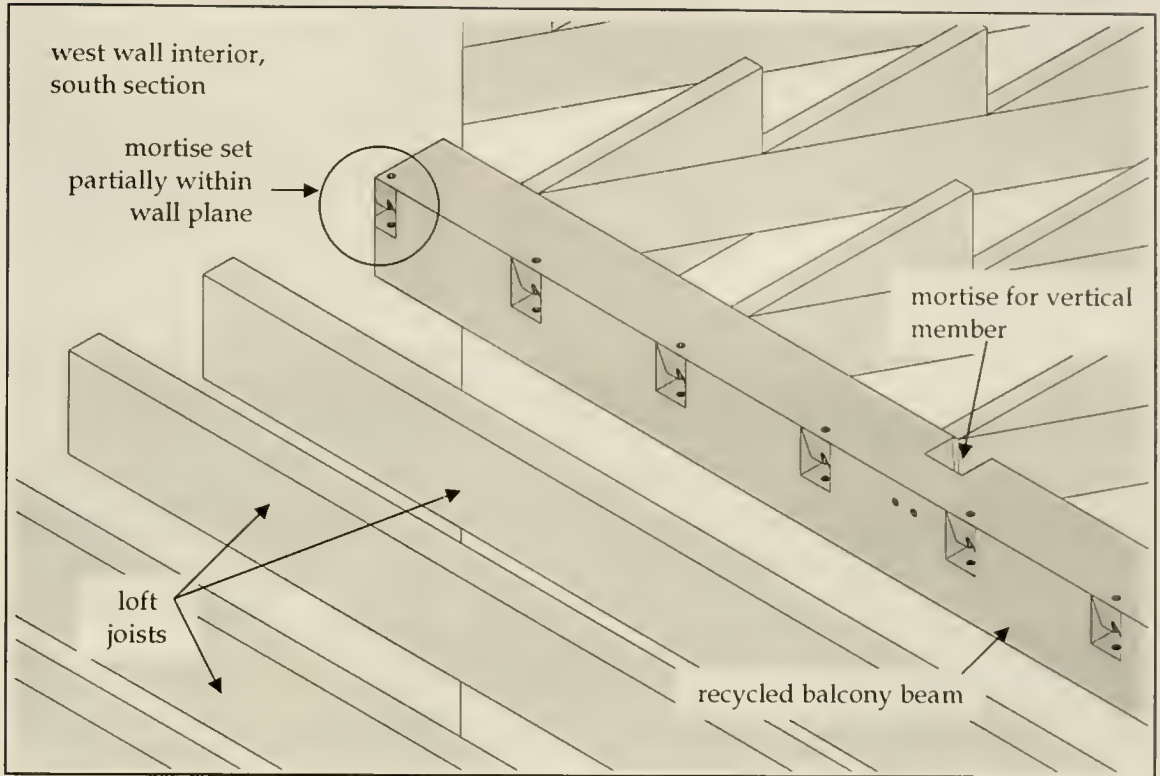
Figure 40:
Plan view detail of recycled balcony beam set in masonry wall. Westernmost mortise is set partially within the wall plane of the west masonry wall. Balcony joists not shown.

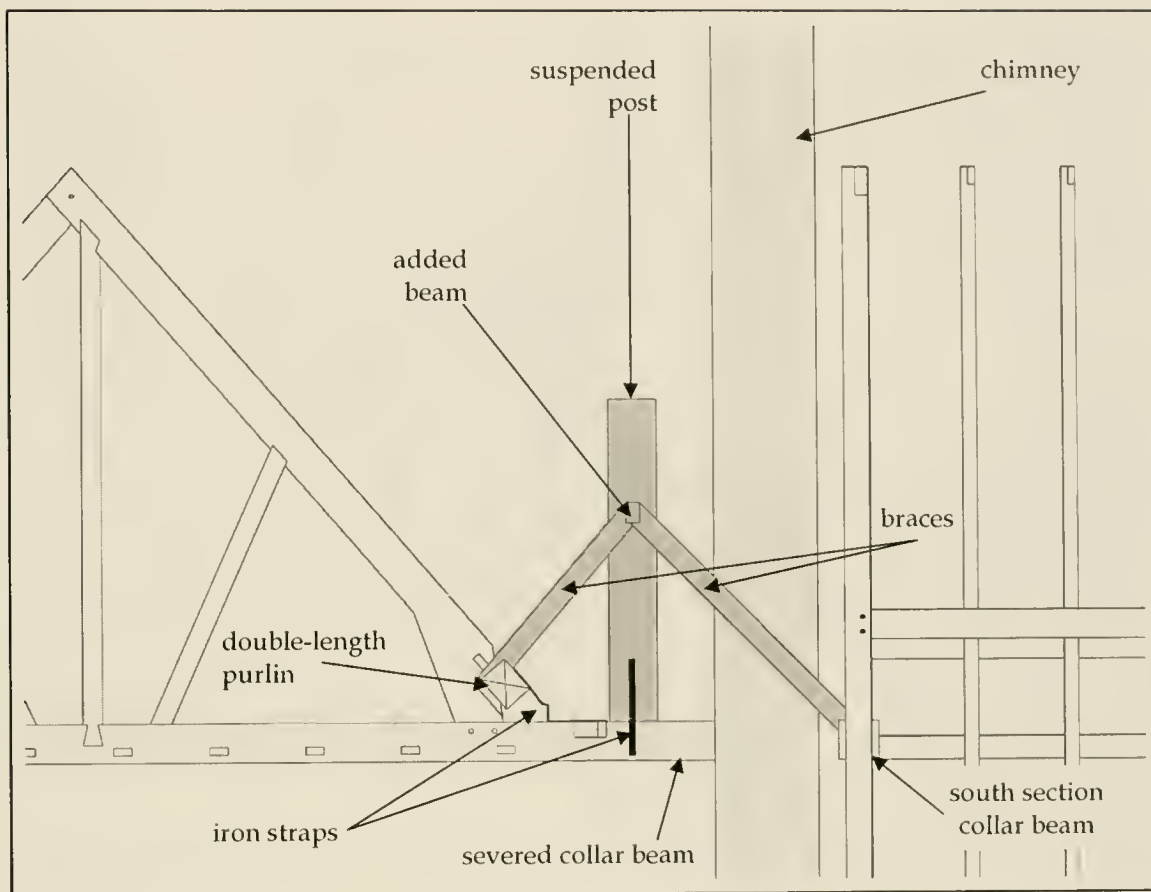
The solution that the carpenters devised was rather resourceful and has been effective for over one-hundred-and-seventy years. The carpenters essentially rigged a variation of an A-frame from which to hang the severed collar beam (Figures 43 - 45). Four diagonal braces running from the double-length purlin and four diagonal braces running from the collar beam of the northernmost principal rafter assembly of the south section together support a small 8-foot beam that crosses above the extended collar. A wide post measuring 2-½ inches thick by 9-¼ inches wide by 5 feet 2 inches high was hung with a through-notch from the makeshift beam extending down to the top of the cut collar (Figure 46). A bolted iron strap connected the suspended post to the extended collar (Figure 47). A second iron strap connected the extended collar beam directly to the double-length purlin. By means of this jerry-rigged frame, the structural load carried by the center principal rafter assembly was thereby transferred to the double-length purlin of the north section and the collar beam of the northernmost principal rafter assembly of the south section from which the extended collar was detached. Several braces running from the adjacent common rafters were also fastened to the makeshift structure to stabilize and reduce any lateral movement.

The lumber used for the jerry-rigging shows marks of pit-sawing and appears to be recycled from original roof framing members. Several of the joists that run among the collar beams of the principal rafter assemblies over the loft are missing. The third, fourth, and fifth joists, counting from the west, that extended between the south gable wall and the first assembly have been sawed off near the wall plane (Figure 52). The south ends of the joists are still visible in their masonry pockets. The reason for their removal is unclear. The sixth joist, counting from the west, which spanned between the first and second assemblies over the south section, has also been removed. The diagonal braces of the jerry-rigged support frame were built from lumber of similar dimensions as these collar joists. It is possible that these four joists were removed and re-used in the jerry-rigged support frame when the chimney was built circa 1829.

Figure 43:
Plan view of added A-frame roof support for severed collar beam.

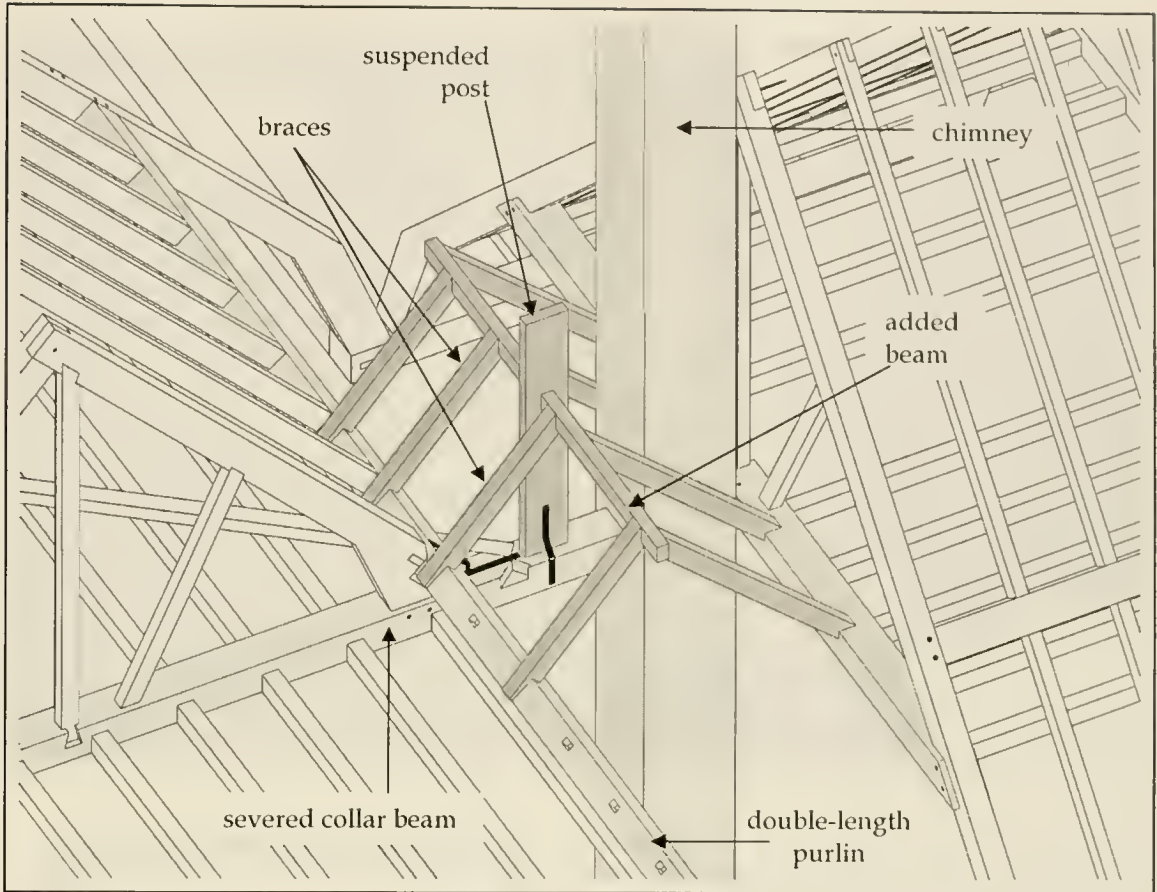
Figure 44:
Section view of added A-frame roof support for severed collar beam looking east.

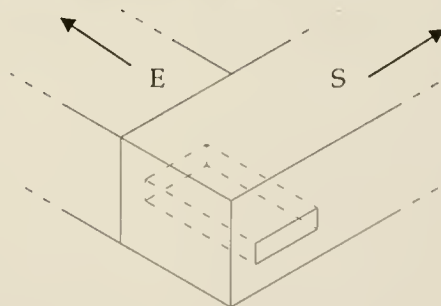
The rafter plates below the valley at the western juncture of the two sections have also been altered. The rafter plates at the eastern juncture are of similar dimensions - 9-½ inches wide by 7 inches high - and are joined by mortise-and-tenon (Figure 54). The western plates are of different dimensions and are not joined but simply meet perpendicularly. The plate that rests on the southwest wall of the north section, in fact, has been replaced by two stacked pieces of timber each measuring 8-½ inches wide by 3 inches high (Figure 55). It seems that at least part of the original plate was removed and replaced with the composite members.

Figure 54:
Rafter plate joint at southeast corner of two sections. The rafter plates are the same dimensions and are joined with mortise-and-tenon as shown in diagram. Photograph by author, 2001.

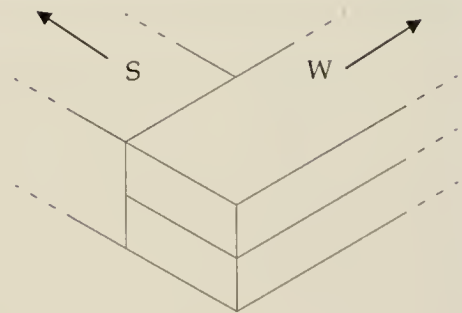
Figure 55:
Rafter plate joint at southwest corner. The plates are different dimensions and meet without joining as shown in diagram. Damaged timber was replaced. The east/west plate has been rebuilt using two stacked pieces of lumber. Photograph by author, 2001.

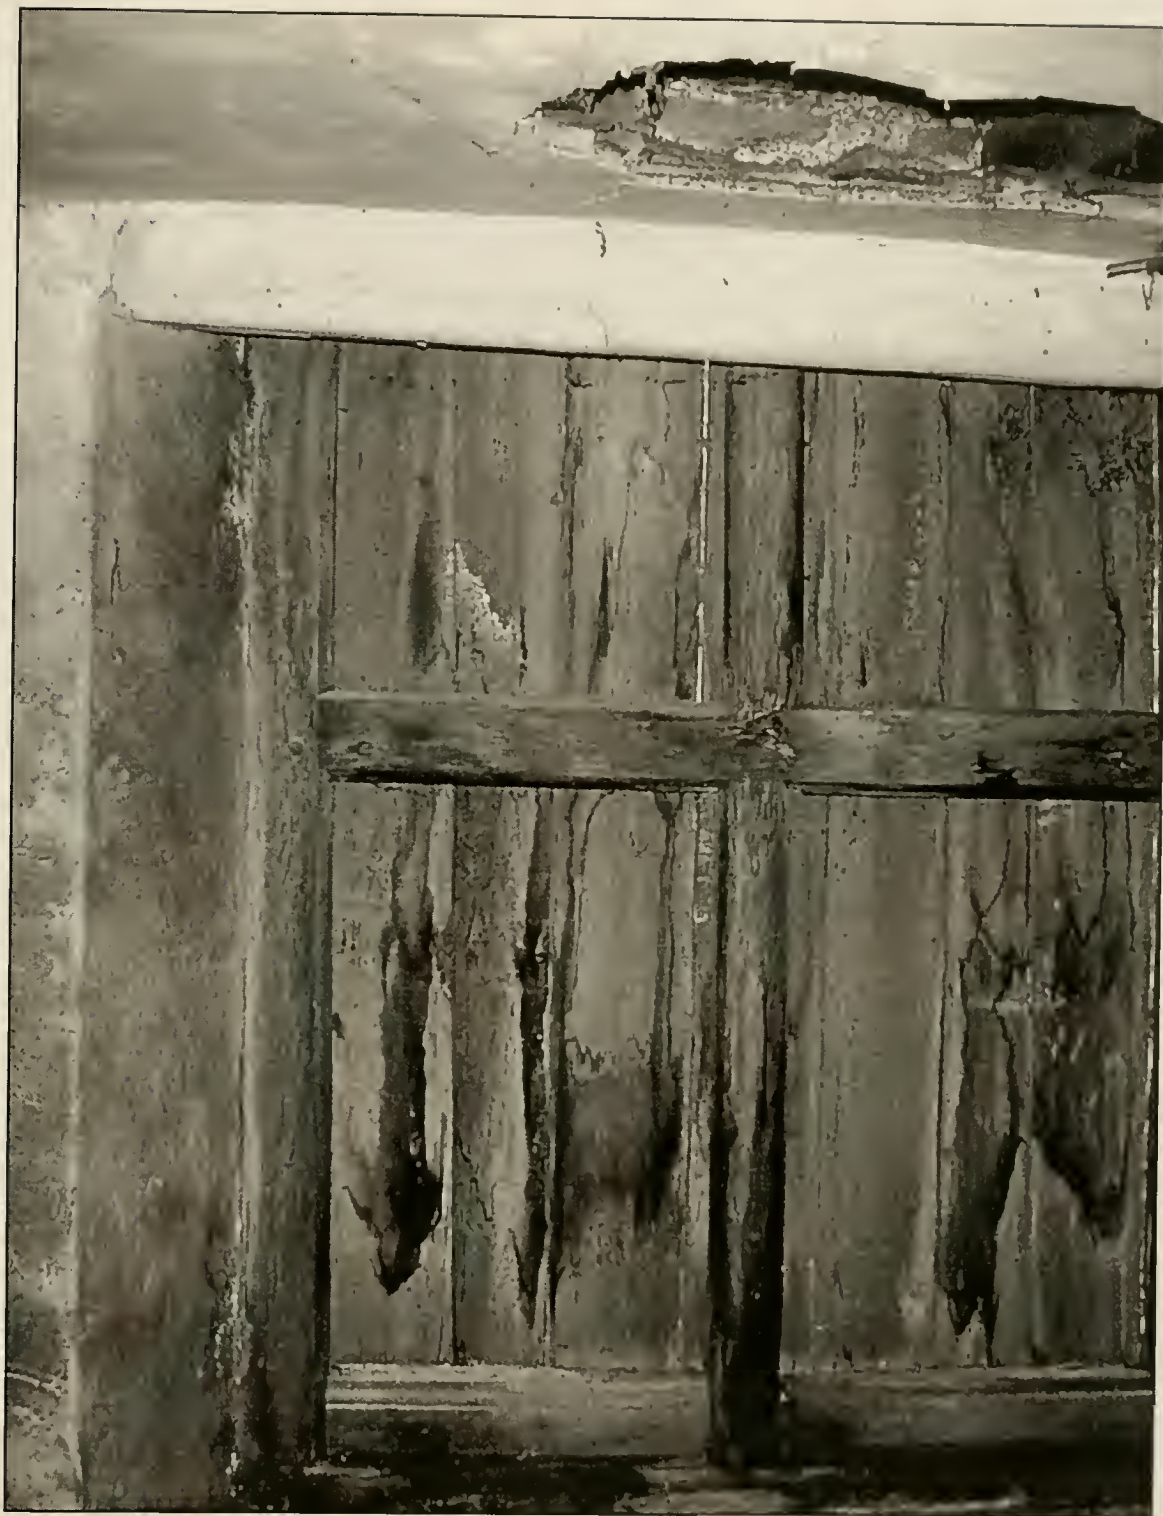
Casement frames that date from the seventeenth and early eighteenth centuries that have survived typically do so without their mullions and intermediate structural members. The casement frames at Merion were sealed in place with exterior batten shutters when the dropped ceiling over the main meeting room was added during the 1829 “Repair” campaign. Enclosing the frames *in situ* has helped to protect them from removal, severe damage and deterioration. The frame located in the upper wall of the northeast gable still retains its vertical mullion and the casement frame that survives in the northwest gable wall retains both its vertical and horizontal mullions (Figures 56 & 57). Details including the decorative ogee profiles of the structural members can still be discerned. The lights and lead comes have been lost, but the remarkable amount of fabric that does survive reveals the original configuration of the windows (Figures 59 & 60). Evidence indicates that the leaded glass panes were nailed into the frames and supported with vertical stiffener rods. The lights in these windows, located high above the ground floor below, were fixed in place and did not open.

Figure 56:
Interior view of casement window frame, northwest gable wall.
Photograph by author, 2002.

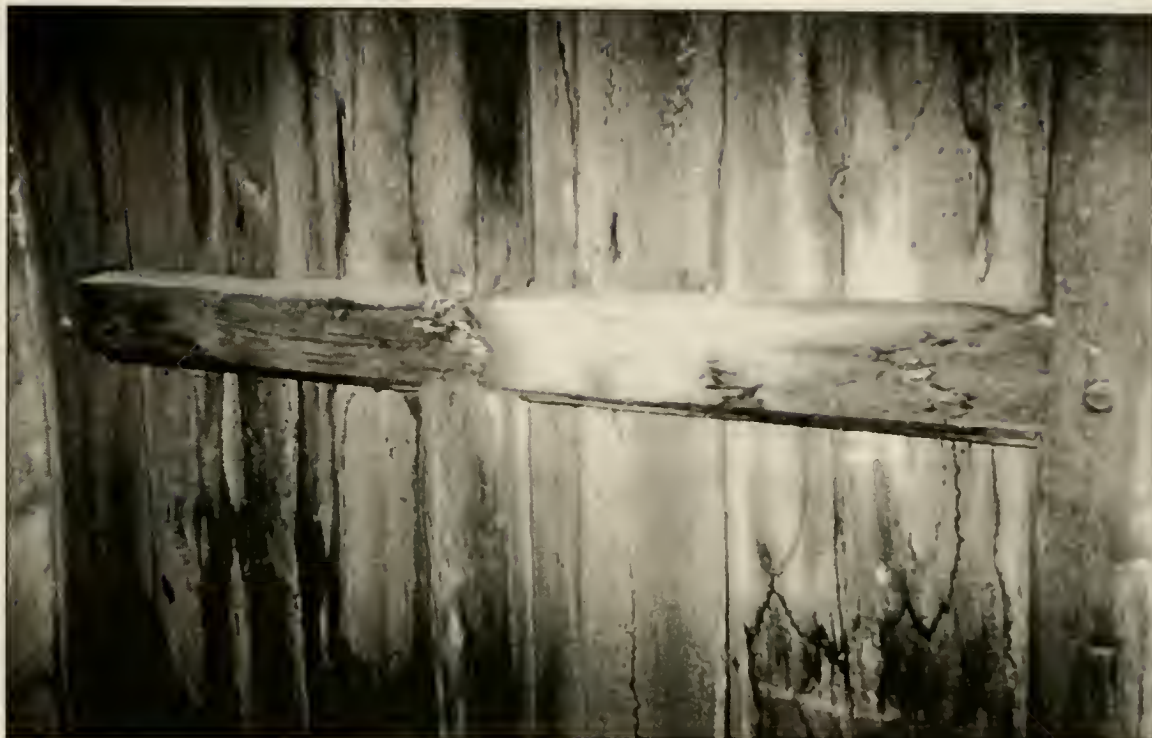
Figure 57:
Detail of vertical and horizontal mullions of casement window frame, northwest
gable wall.
Photograph by author, 2002.

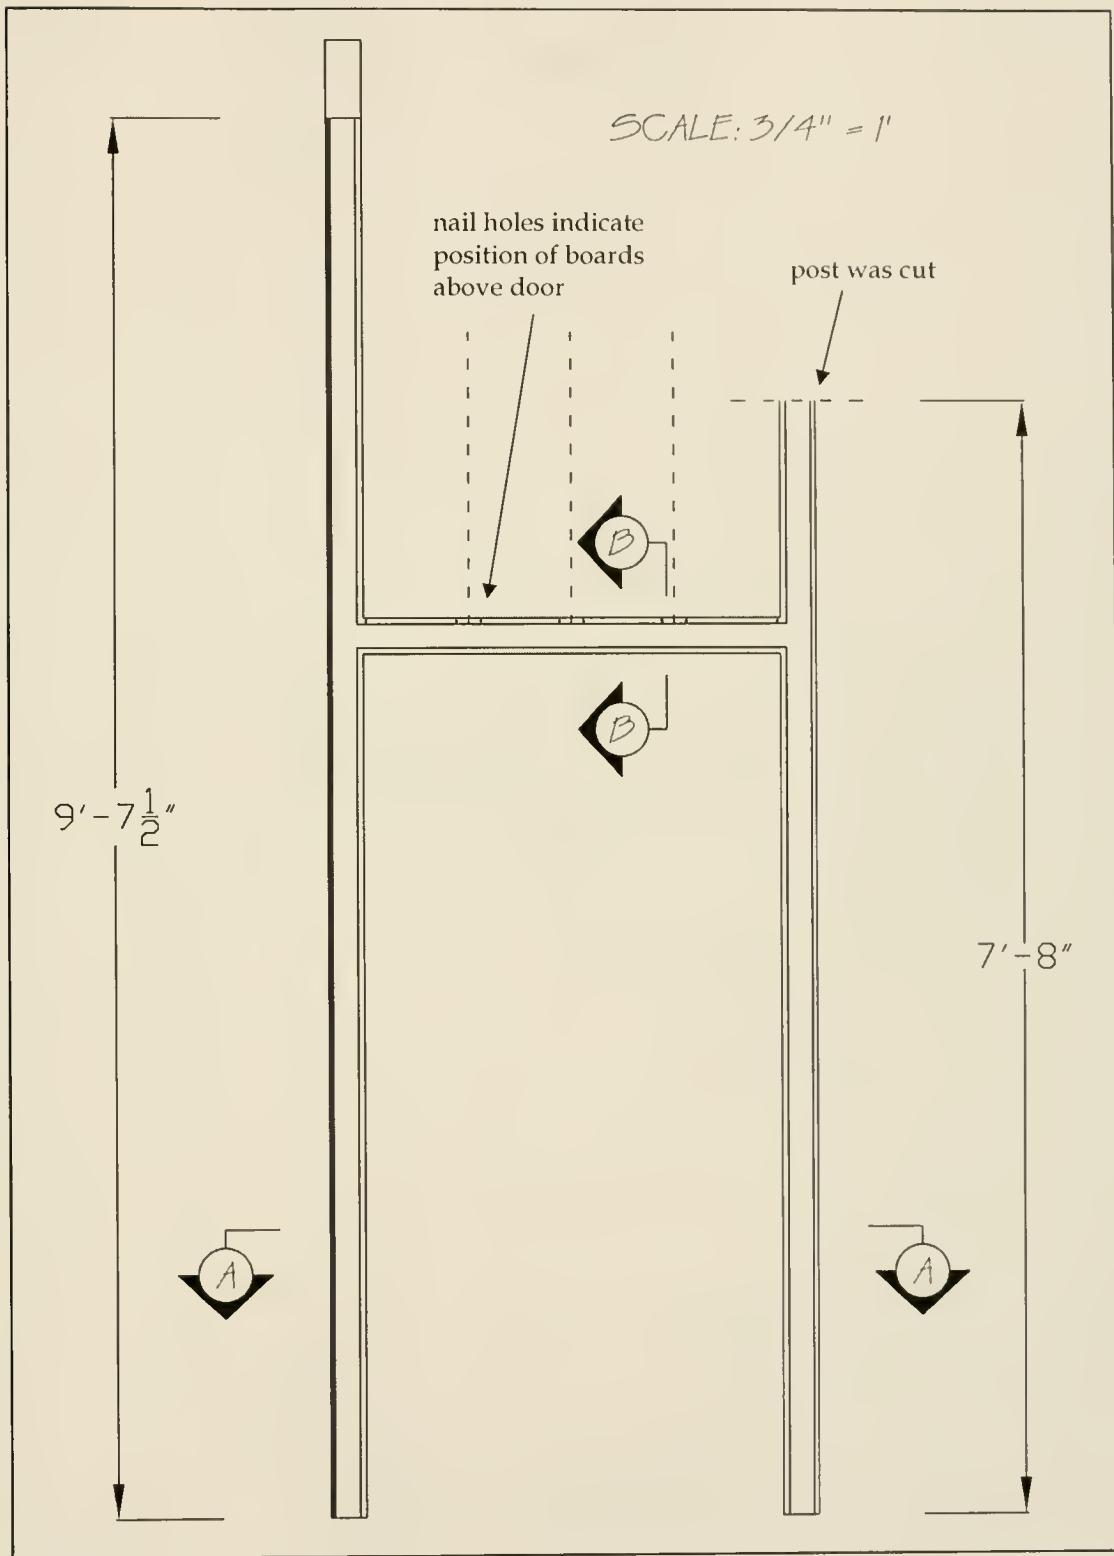
The doorframe of the partition wall is also recycled. It is nailed in place with nineteenth-century cut nails, but its construction and section profile suggest a much earlier date of origin (Figure 61). It is constructed of two vertical jamb posts and a crossing lintel connected with mortise-and-tenon joints. The eastern post, as it is currently situated, has been cut to an approximate height of 7 feet 8 inches to accommodate the slope of the roof. The western post rises to a height of 9 feet 10 inches above the current floor plane with a 6-½ inch rabbeted notch cut across the top. The rabbeted notch

probably corresponded to a horizontal beam or joist to which the partition wall was attached. The jamb posts are decorated with a modest bead and have full-height, vertical grooves cut in them to receive tongued partition boards (Figures 62 & 63). The western post has two separate grooves – one parallel and one perpendicular to the door plane. The two grooves indicate that the post was at the intersection point of two separate partition walls. The doorway must have led at one time to a smaller room or partitioned compartment. This configuration suggests that the doorway once opened to an enclosed staircase or possibly a closet.

Figure 61:
South elevation of loft door frame. See Figures 62 & 63 for details of Sections A & B.
